Sassoni E., Graziani G., Franzoni E., Scherer G.W., Calcium phosphate coatings for marble conservation: influence of ethanol and isopropanol addition to the precipitation medium on the coating microstructure and performance, Corrosion Science 136 (2018) 255–267

## **Calcium phosphate coatings for marble conservation: influence of ethanol and isopropanol addition to the precipitation medium on the coating microstructure and performance**

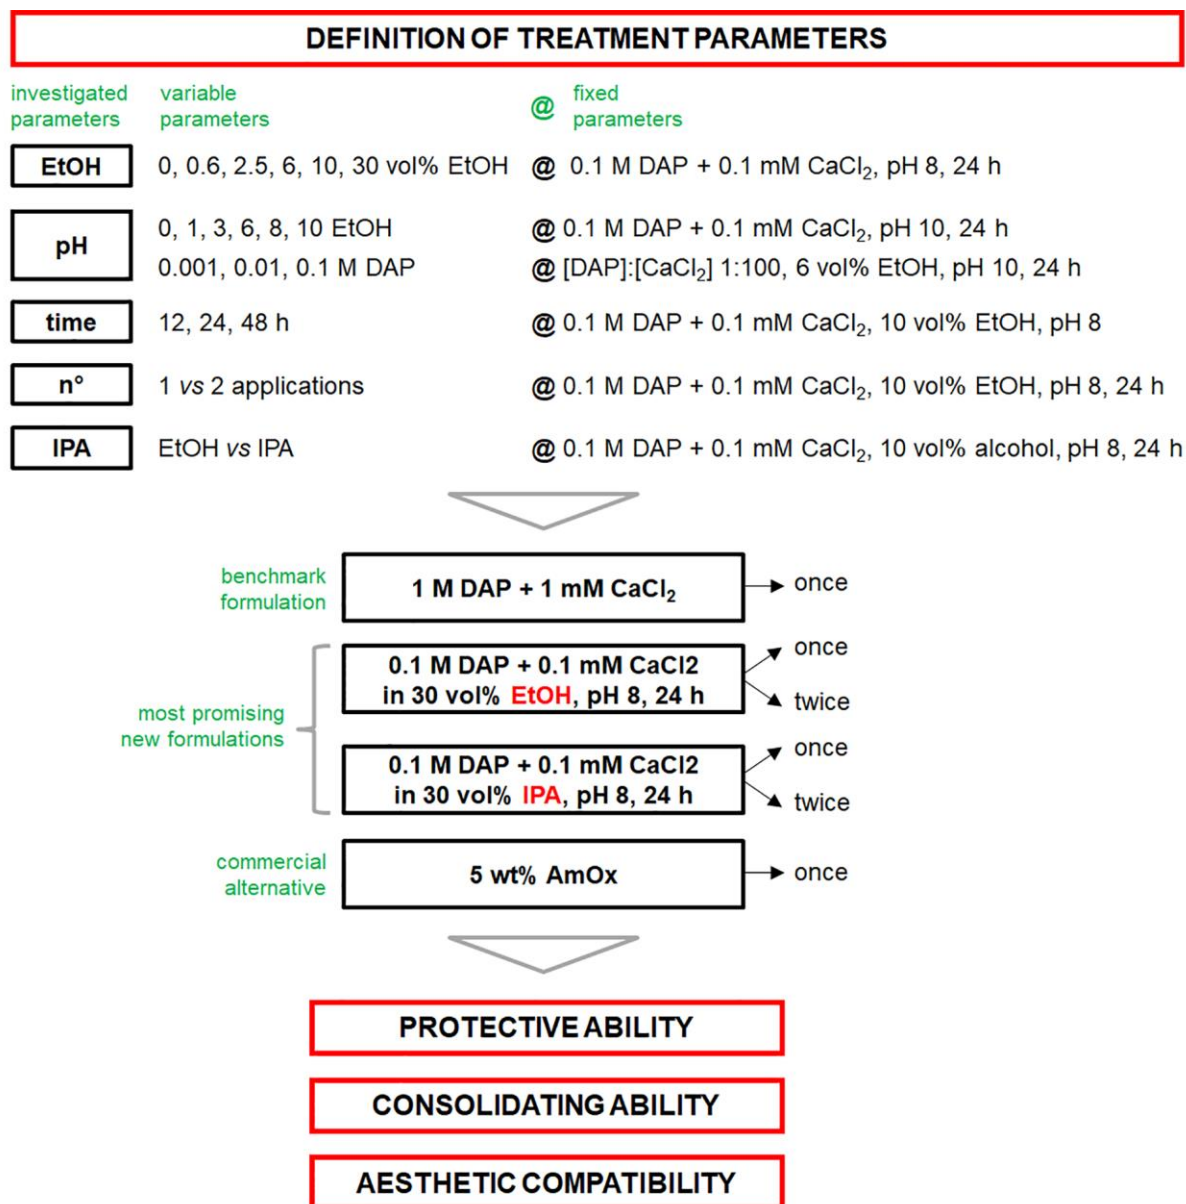
**Figure 1.** Scheme illustrating the investigated parameters and the whole rationale of the study.

The possible improvement of this formulation, in terms of surface coverage and microstructure, was investigated by exploring the influence of the parameters described in § 2.2.1 - § 2.2.5. A summary of the investigated parameters is reported in Figure 1. Treatment by a 5 wt% aqueous solution of ammonium oxalate (labelled as “AmOx”) was also taken as a commercial benchmark. All treatments were performed by immersing a cubic specimen in a plastic container with 200 ml of solution and then rotating the containers to ensure stirring of the solutions during treatment. The treatment duration was 24 hours, unless otherwise specified. At the end of the treatment, the specimens were taken out of the solutions, rinsed with deionized water and then dried at room temperature. The features of the different coatings were determined as described in § 2.2.6.

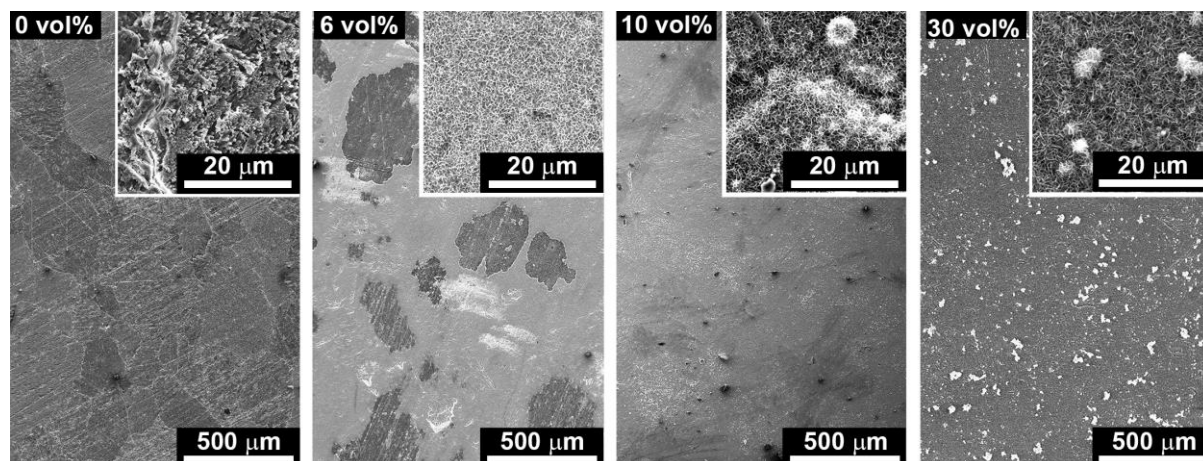
**Figure 2.** Coverage of marble surface by CaP coatings formed by reaction with a 0.1 M DAP and 0.1 mM  $\text{CaCl}_2$  solution containing increasing amounts of ethanol.

When the DAP concentration was reduced and ethanol was added to the solution, cracking was prevented and a much denser microstructure was achieved (Figure 2), which allowed a significant improvement in the protecting ability (“EtOH” sample in Figure 2). The time required for pH increase from 4.75 to 5.75 was more than doubled (from 3.9 h to 8.3 h, Table 2), and the “EtOH” curve remained below the untreated reference “UT” for the whole duration of the test (Figure 9). When observed after the acid attack test (Figure 10), the coating exhibited no diffused detachment (unlike the “1 M DAP” sample), but still some cracking, which allowed the acid to reach the substrate and cause the increase in pH registered after some time.

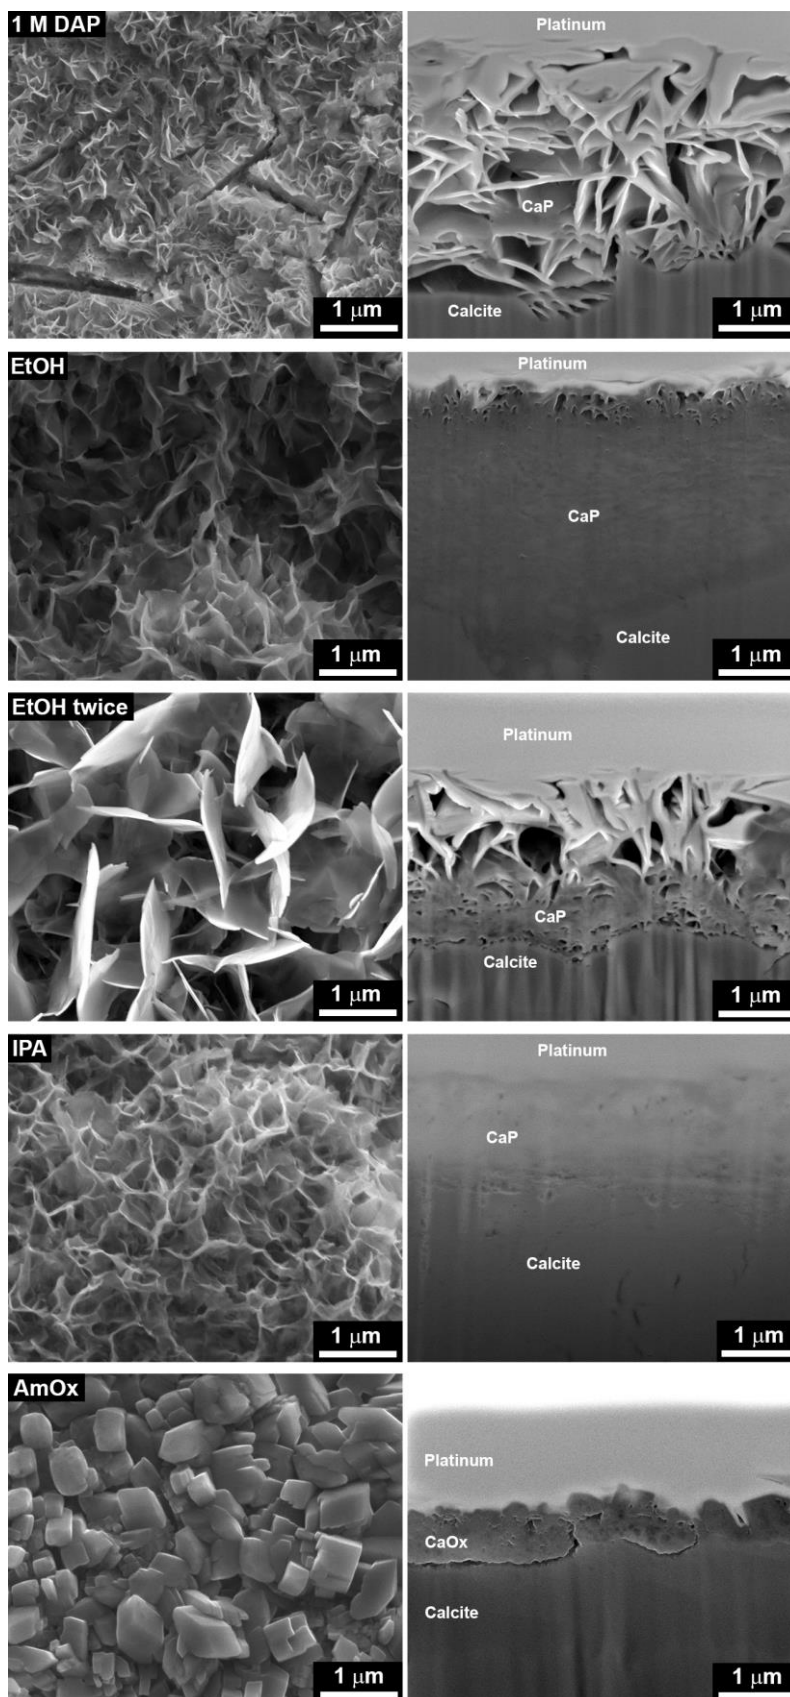
**Figure 3.** Surface morphology (left) and cross section (right) of marble samples subjected to different treatments.

Because repeated treatments had been found to significantly improve the surface coverage of marble particles by CaP coatings [22], the effect of repeating the “EtOH” treatment twice was investigated. As reported in Figure 3, this led to formation of huge CaP flakes on top of the coating, visible both from observation of the treated surface and in the FIB cross section (Figure 3). Even if the underlying layer exhibits a much denser microstructure than the superficial flakes, the adhesion at the coating-substrate interface seems worse compared to the single application, likely because the second treatment caused excessive growth and partial detachment of the coating from the substrate.

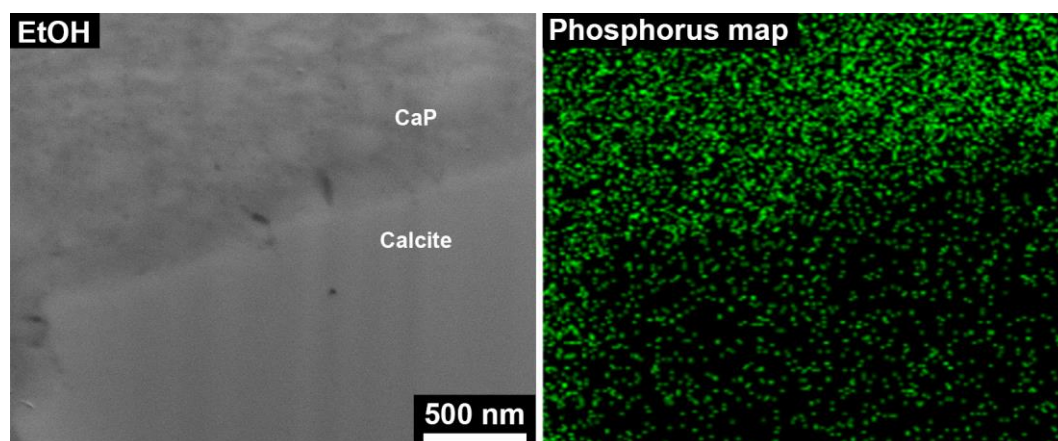
**Figure 4.** Interface between the calcite substrate and the CaP coating (left) and corresponding phosphorus map (right).

In addition to the increased surface coverage, ethanol addition also had a significant effect on the coating microstructure and tendency to crack. If one compares a specimen treated with a solution containing 0.1 M DAP, 0.1 mM  $\text{CaCl}_2$  and 10 vol% ethanol (“EtOH” sample) with a specimen treated with a 1 M DAP and 1 mM  $\text{CaCl}_2$  solution (“1 M DAP”), the following observations can be made. In both cases complete coverage of the marble surface is achieved. However, the “1 M DAP” specimen is affected by some cracking, likely developed during drying, while the “EtOH” specimen exhibits no visible cracks (Figure 3). In terms of porosity of the coating, FIB-SEM revealed that numerous large pores are present in the “1 M DAP” specimen (Figure 3), which are expected to negatively affect the acid resistance (cf. § 3.1.6). On the contrary, the “EtOH” specimen exhibits a much denser microstructure and no visible pores (Figure 3), apart from the top of the coating (right after the platinum layer), where the typical flower-like morphology of CaP is present. Notably, at the interface between the calcite substrate and the CaP coating (about 2–4  $\mu\text{m}$  thick), good adhesion seems present (Figure 4).

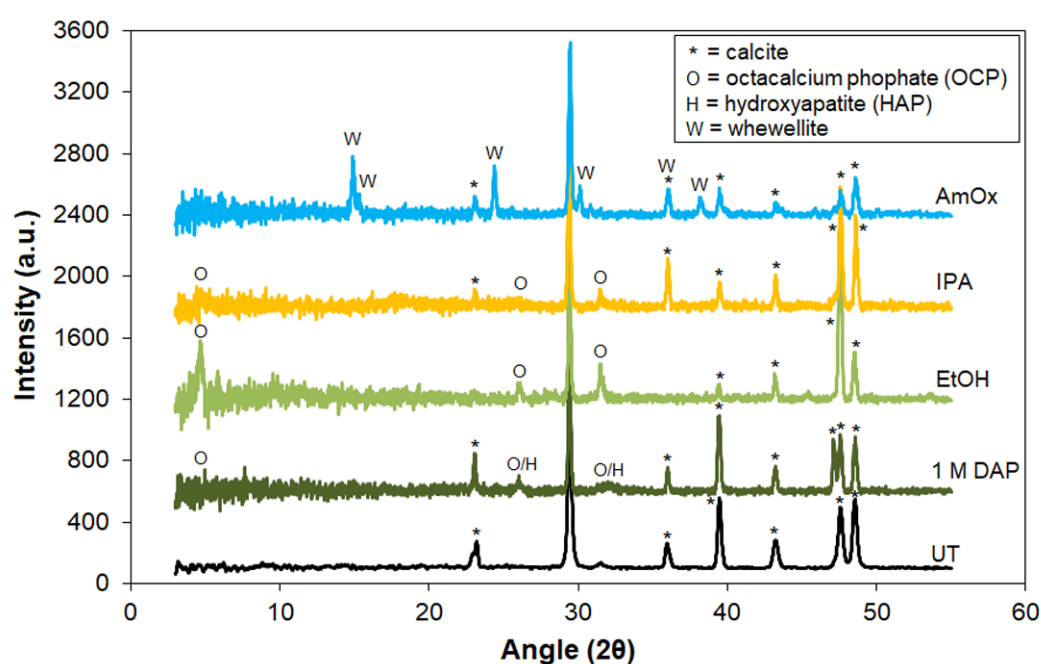
**Figure 5.** Mineralogical composition of untreated and treated specimens.

Consistently with the theoretical expectations, the amount of PO<sub>4</sub><sup>3-</sup> ions in solution when 10 vol% IPA was added was found to be much higher than when the same amount of ethanol was added (0.71 mg/l vs 0.32 mg/l, respectively), basically corresponding to a 30 vol% ethanol addition (0.76 mg/l) (Table 3). Accordingly, the microstructure of the CaP coating formed with IPA addition was even denser than in the case of ethanol, the interface between the calcite substrate and the coating being hardly distinguishable (Figure 3). In terms of composition, the coating consisted of OCP, as in the case of ethanol addition (Figure 5).

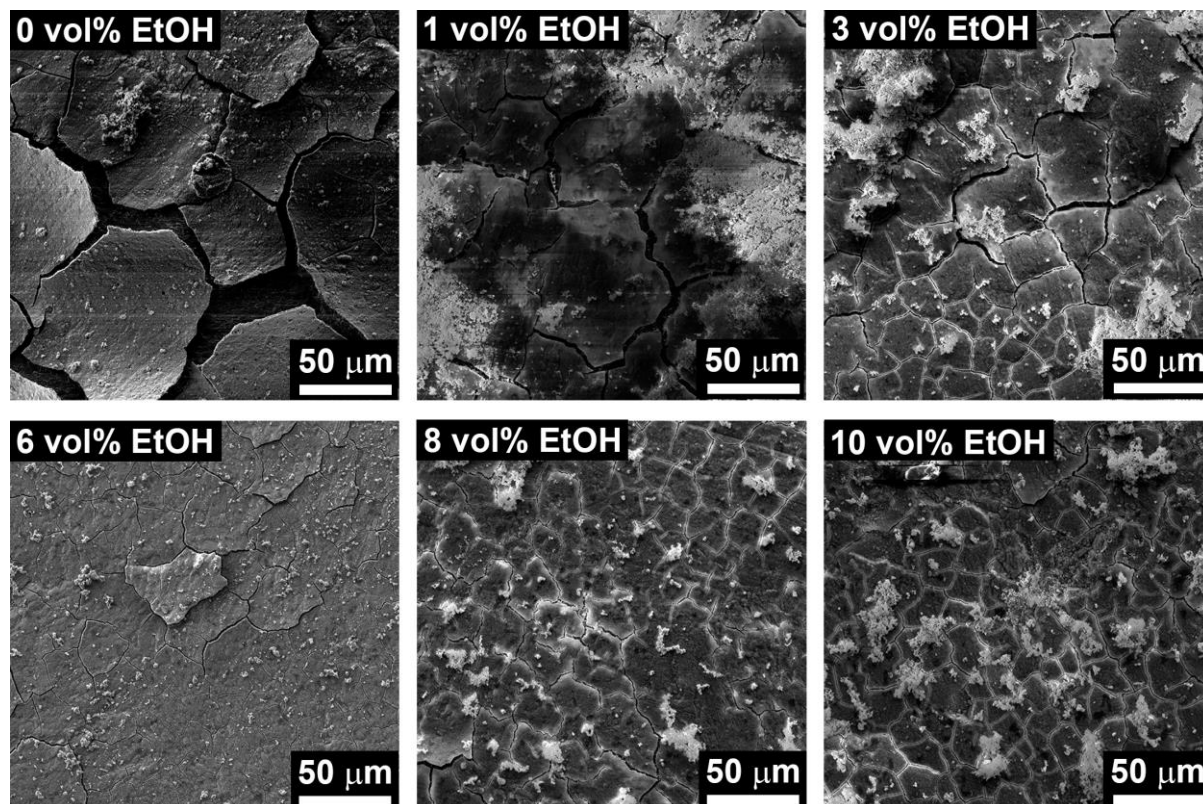
**Figure 6.** Morphology of CaP coatings formed at pH 10 for increasing amount of ethanol addition to the DAP solution.

Increasing the pH of the DAP solution to 10 using  $\text{NH}_4\text{OH}$  had a huge effect on the CaP coating development, as illustrated in Figure 6. Even with no ethanol addition, at pH 10 abundant formation of new phases occurred when marble was treated with a 0.1 M DAP and 0.1 mM  $\text{CaCl}_2$  solution, while no formation took place at pH 8 (Figure 2). This is a consequence of the higher amount of  $\text{PO}_4^{3-}$  ions originating from DAP dissociation at high pH [19]. However, because of excessive growth, the CaP coating is extensively cracked (Figure 6), which prevents effective acid protection. To try to avoid cracking, two routes were tested. First, increasing ethanol additions to the DAP solution were tested, to develop a more adherent coating with more refined

microstructure. As illustrated in Figure 6, a reduction in cracking and flake detachment was achieved, but cracks were not completely eliminated. Moreover, the combination of high pH and high ethanol additions led to an excessive  $\text{PO}_4^{3-}$  amount, which resulted in abundant precipitation of CaP particles over the coating (Figure 6). Therefore, considering that at higher pH a lower concentration of DAP could be enough to achieve complete surface coverage, a progressive reduction in DAP concentration from 0.1 M to 0.01 M and 0.001 M was tested (the  $\text{CaCl}_2$ :DAP concentration always being 1:1000). As illustrated in Figure 7, a DAP concentration of 0.01 M at pH 10 was enough to obtain complete coating of the surface. However, the coating exhibited some cracking (Figure 7). A further reduction of the DAP concentration by 10 times led to no coating formation (Figure 7), because the  $\text{PO}_4^{3-}$  content became too low. Since the boosting effect of high pH was always linked to cracking in the tested conditions, only treatments at pH 8 were considered for the prosecution of the study.

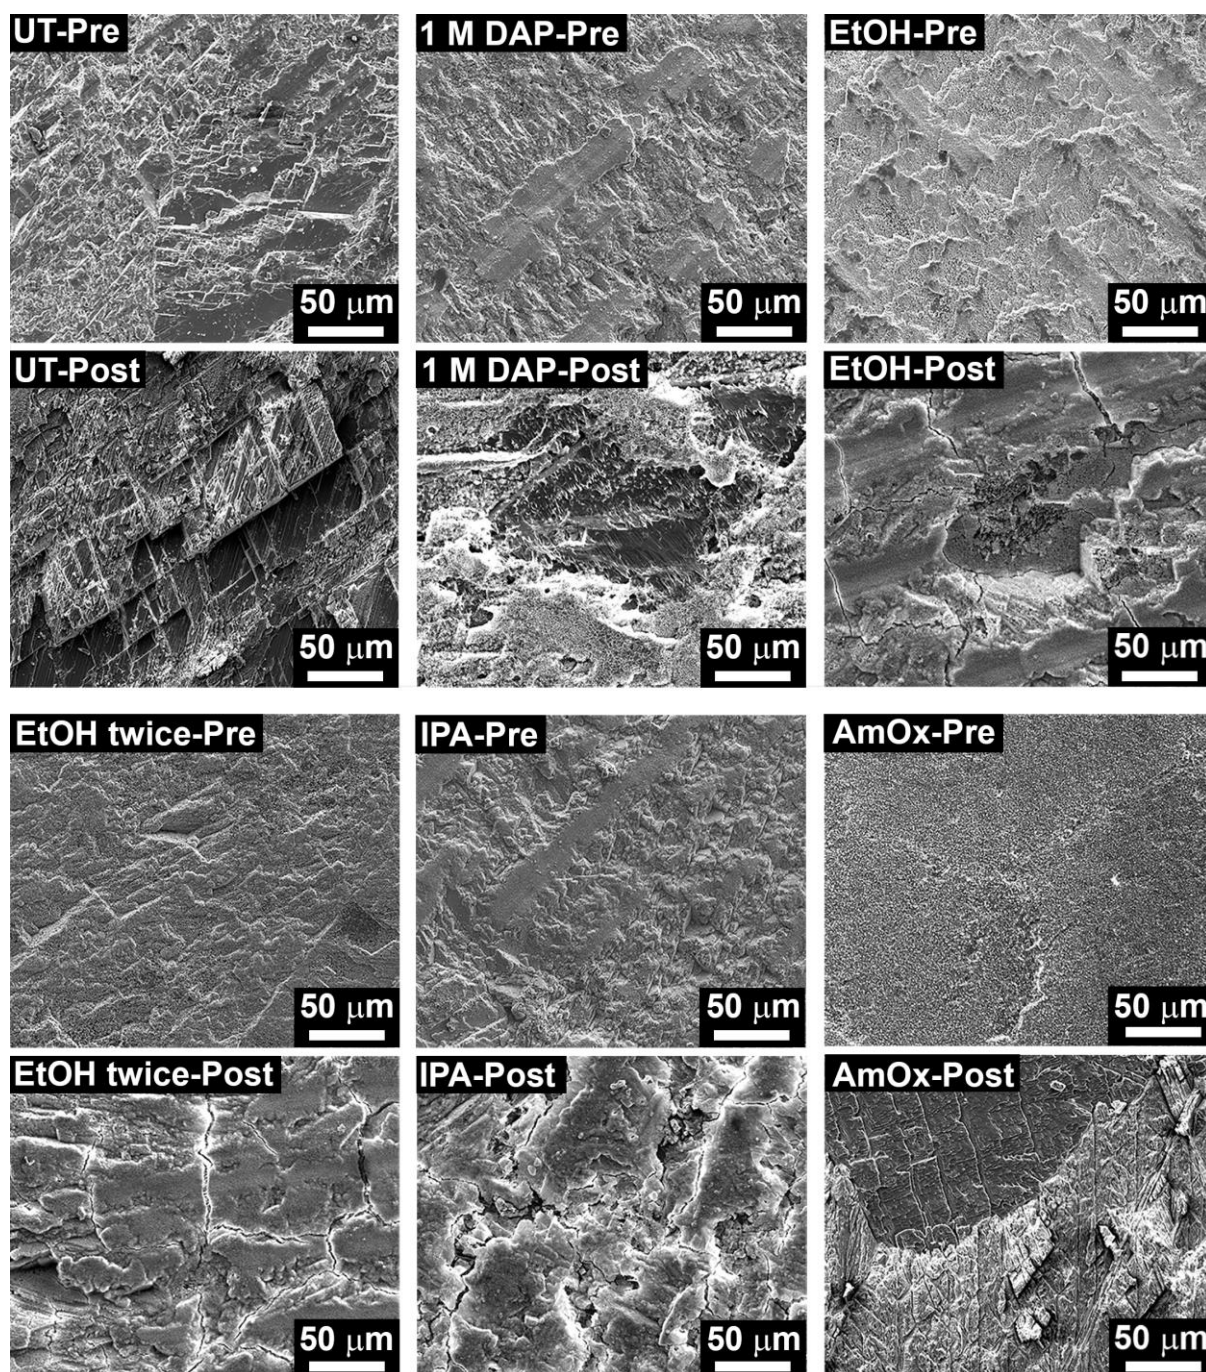
**Figure 10.** Surface morphology of untreated and treated specimens, before ("Pre") and after ("Post") the acid attack test.

For the most promising formulations of the phosphate treatments (namely, “EtOH”, “EtOH twice”, “IPA” and the reference “1 M DAP”, Table 2), as well as the reference conditions “UT” and “AmOx”, the results of the acid attack test are illustrated in Figure 9. Results are expressed in terms of pH increase over time of the acid solution simulating rain, in which the samples had been immersed. The appearance of the coating before and after the acid attack test is illustrated in Figure 10.

First, the stability of the solution pH when no sample was immersed was checked and no pH increase was in fact recorded. The “UT” sample caused a quick increase of pH during the test (Figure 9). This increase is due to H<sup>+</sup> ions in the solution being consumed as Ca<sup>2+</sup> ions are released from calcite [1]. Since the Ca<sup>2+</sup> concentration increases as the test proceeds, the rate of dissolution decreases, because the dissolved Ca<sup>2+</sup> ions remain in the solution [1]. At the end of the test, the marble surface is significantly etched, so that single grains and grains boundaries become apparent (Figure 10).

The acid resistance of the “IPA” sample resulted improved with respect to the “EtOH” sample, especially at the beginning of the test (Figure 9), the time required for pH increase to 5.75 being the longest (8.7 h against 8.3 h for the “EtOH” sample and 3.9 h for the “UT” reference, Table 2). The ESEM observation of the coating after the acid attack test revealed that no diffuse detachment occurred, even if cracks are visible (similarly to the case of the “EtOH” sample) (Figure 10).

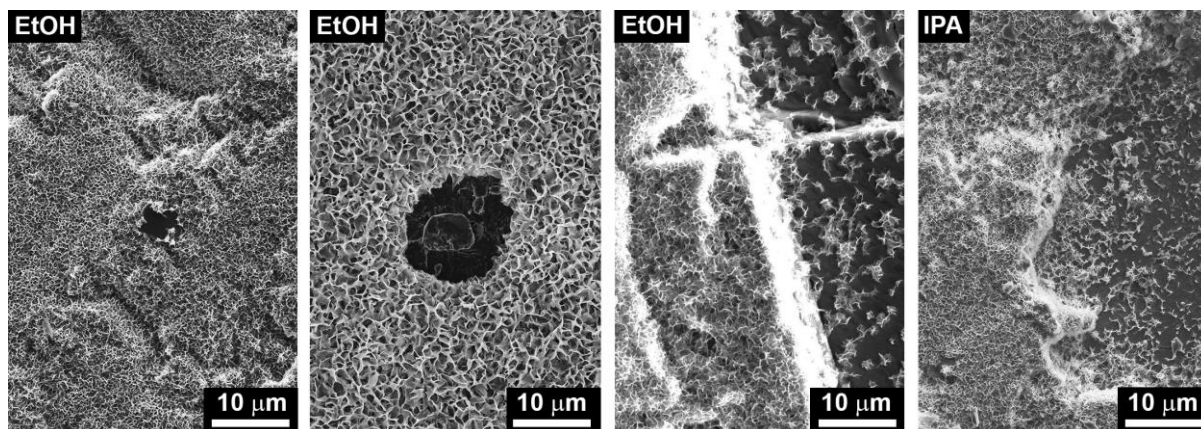
**Figure 11.** Interruptions in the CaP coating due to the presence of impurities (left two images) and due to the different crystallographic orientation of calcite grains (right two images).

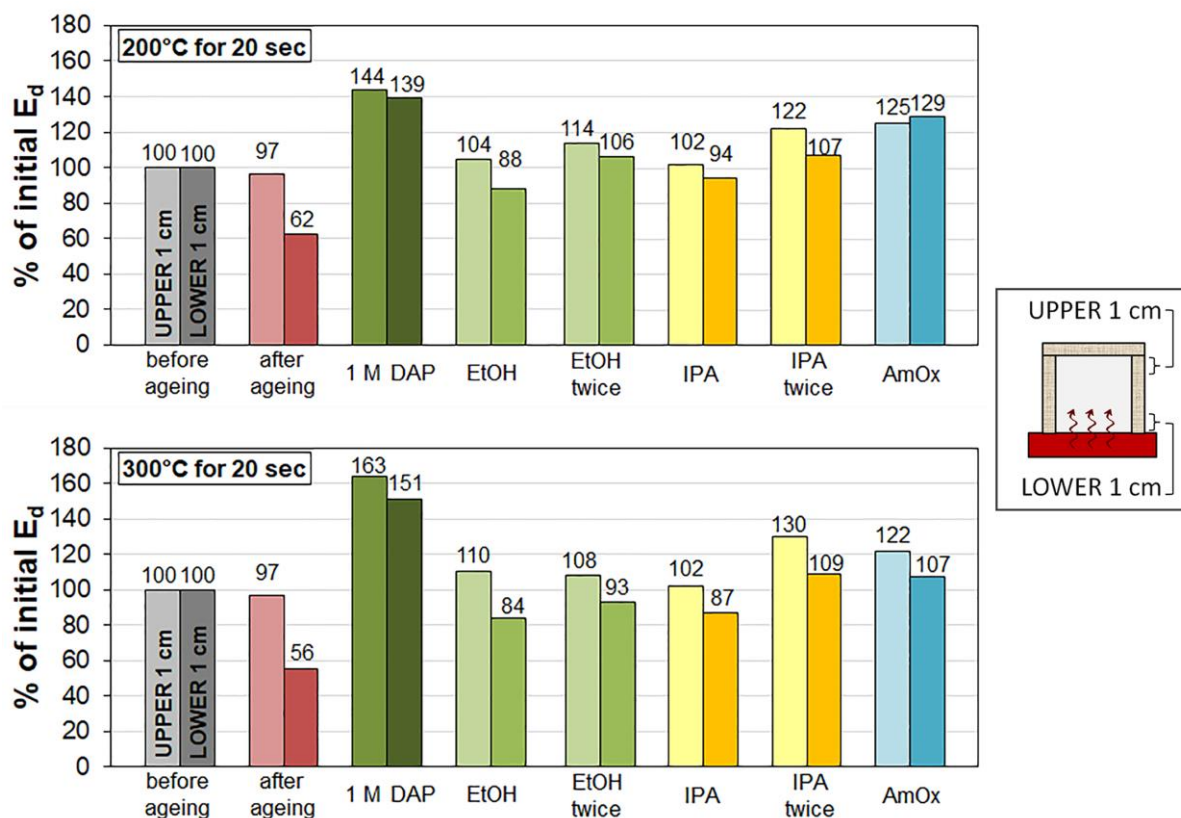
**Figure 12.** Variations in dynamic elastic modulus ( $E_d$ ), with respect to the initial value, after accelerated ageing and after consolidation by different treatments. Values refer to the lower and upper 1 cm of the specimens, which had been subjected to accelerated ageing as illustrated in the inset: one face of the specimens was put in contact with the hot plate (in red), while the sides and the top were wrapped with a high temperature resistant insulator (in grey), to ensure the uni-directional heat flux.

After accelerated ageing by contact with a hot plate for 20 seconds, in the first 1 cm from the heated surface the specimens exhibited a 38%  $E_d$  decrease after heating at 200 °C and a 44%  $E_d$  decrease after heating at 300 °C (Figure 12). These values are in very good agreement with those predicted by the mathematical model (35% and 42%, respectively) [28], which was used to calculate the heating temperature and time required to produce damage similar to that experienced in the field by naturally weathered marble [27-29]. At the same time, the upper 1 cm of the sample underwent no substantial  $E_d$  decrease (Figure 12), as expected.

Consolidation by the “1 M DAP” treatment proved to be the most effective among all the investigated treatments, being able to increase  $E_d$  in the weathered part up to 139% (samples heated at 200 °C) and 151% (samples heated at 300 °C) of the initial value. The higher consolidating efficacy in samples with higher initial damage is consistent with previous results obtained on limestone [21]. The fact that the “1 M DAP” treatment was able to increase mechanical properties the most, in spite of the presence of cracks and pores in the formed CaP layer, derives from the following fact. Whereas in the case of *protection* it is essential that the formed coating continuously cover the surface and be crack- and pore-free, in order to prevent acid from reaching the substrate, this is not as important in the case of *consolidation*. In this latter case, the main requirement is that the newly formed material be able to seal the tip of the cracks among grains [50]. If the crack tip is effectively sealed, then the continuity of the coating and the presence of cracks and pores are not as detrimental as in the case of acid protection (however, cracks in the coating might propagate to the crack between grains, so uncracked coatings are nevertheless preferable). A potentially negative aspect of the high consolidating effectiveness of the “1 M DAP” treatment is that not only the initially deteriorated part (lower 1 cm), but also the initially sound part (upper 1 cm) underwent a significant mechanical improvement (Figure 12). This is undesired, because over-strengthening of the sound part might lead to mechanical incompatibility between the treated part and the substrate, potentially leading to its detachment [51,52]. Therefore, treatments able to restore mechanical properties of the weathered part, without causing excessive strengthening of the sound part are recommended [51,53].

Specimens consolidated by “AmOx” exhibited remarkable mechanical improvement, second only to the “1 M DAP” specimens (Figure 12). In fact, the initial modulus in the weathered part was completely restored and even enhanced after a single application ( $E_d$  up to 129% and 107% in specimens heated at 200 and 300 °C, respectively), with considerable strengthening also of the sound part ( $E_d$  up to 122–125%). Such mechanical improvement is notable, considering that in a previous study we found the consolidating ability of the ammonium oxalate treatment to be very modest [29]. The poor consolidating behaviour of ammonium oxalate was ascribed to the reduced depth of formation of whewellite [29], owing to the very rapid reaction between the ammonium oxalate solution and calcite [54]. In addition to the different thickness of samples to be consolidated (1 cm in the present case, 2 cm in the previous case [29]), a possible explanation for the better results obtained in this study may be the different application technique. While in the previous study the ammonium oxalate solution had been applied by brushing [29], in the present study it was applied by vacuum impregnation, which likely allowed to achieve a deeper and quicker penetration of the consolidating solution into marble microcracks, leading to higher strengthening. However, it should be noted that, given the low resistance of the newly formed whewellite to dissolution in acid, it is not unlikely that most of the mechanical improvement induced by the “AmOx” treatment could be lost after prolonged exposure to rain.

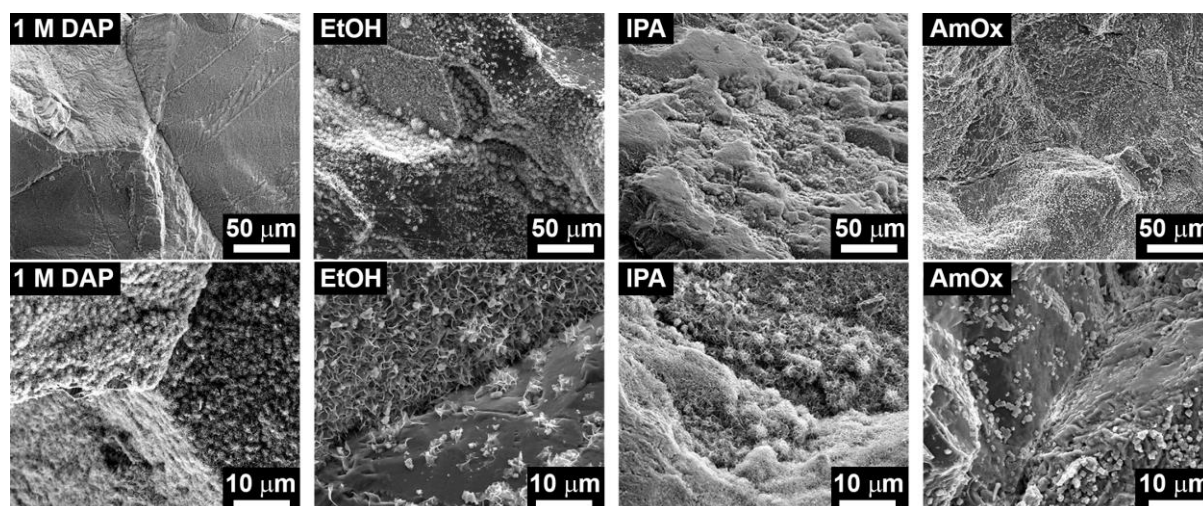
**Figure 13.** New phases formed inside microcracks between calcite grains after consolidation by different treatments.

After the  $E_d$  measurement, the formation of new phases in the microcracks among calcite grains was assessed by ESEM observation of fracture samples obtained by chisel from the tested specimens.
